**DRAFT FINAL SITE INSPECTION WORK PLAN, PRELIMINARY ASSESSMENT,
OTHER AREAS/UTILITIES, VOLUME 1 OF 3 - UNDERGROUND UTILITIES**

HARDING LAWSON ASSOCIATES

DRAFT FINAL
SITE INSPECTION WORK PLAN: PA OTHER AREAS/UTILITIES
VOLUME I of III: UNDERGROUND UTILITIES
NAVAL STATION, TREASURE ISLAND
HUNTERS POINT ANNEX
SAN FRANCISCO, CALIFORNIA

April 1, 1992

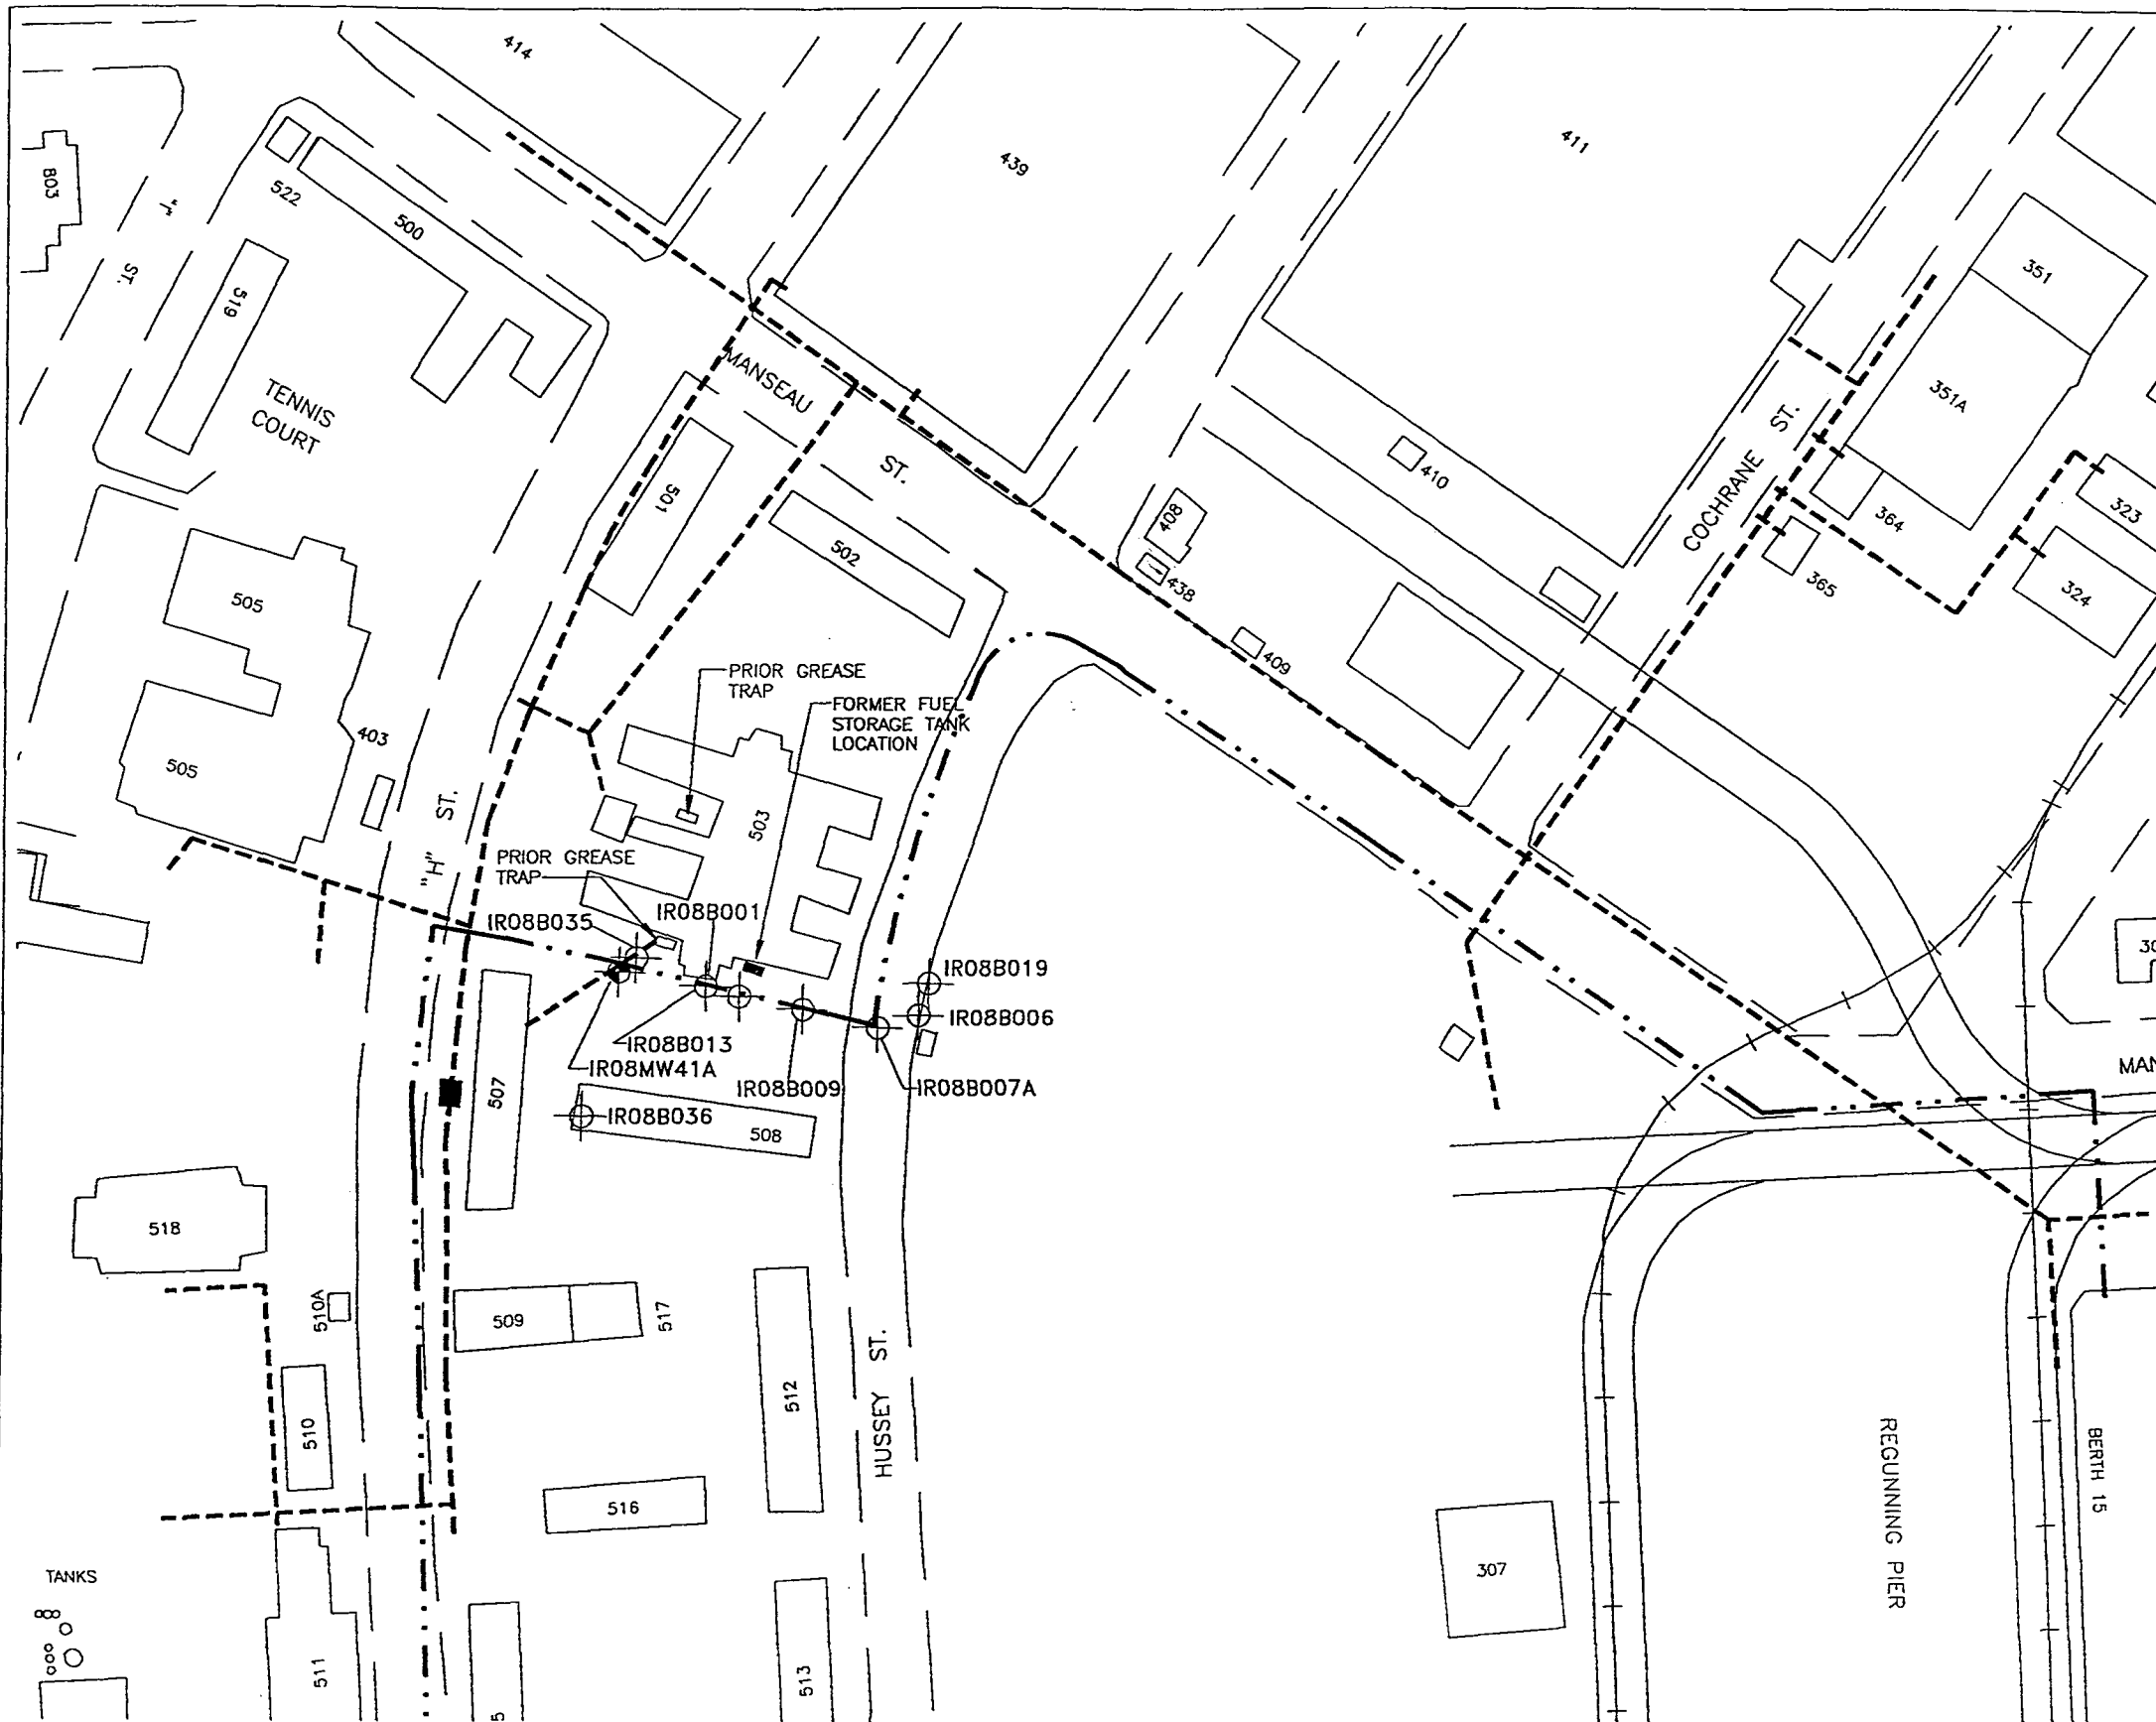
PLATE
6

EXPLANATION	
---	Approximate Location of Suspected Steamlines
---	Approximate Location of Mapped Steamlines
■	Approximate Location of Cut Steamline which Contains Oil
⊕	Existing Soil Boring Adjacent to Suspected Steamline
⊕	Existing Monitoring Well Adjacent to Suspected Steamline

are referenced in the PA Other Areas/Utilities report (HLA, 1990c). The suspected steamlines are reported to have originated at the northwest corner of Berth 15 and to have run along Manseau Street to Hussey Street, then 350 feet along the west side of Hussey Street, west to H Street, and finally south along H Street to the vicinity of the Power Plant. It was also suggested by the EPA and in the PA Other Areas/Utilities report (HLA, 1990c) that these lines may have contained PCB oils and may have been broken and abandoned in place. The approximate location of the suspected steamlines is shown on Plate 6.

(d) The EPA report of information provided by the former HLA employee states that the line runs southwest along H Street toward the Power Plant, but examination of the map shows that H Street runs to the southeast. As compass directions seem to be inaccurate, both the west side of Hussey Street (as stated in the EPA report of HLA employee information) and the east side of Hussey Street and south side of Manseau Street (as shown in plate 6) should be investigated for the presence of buried lines.

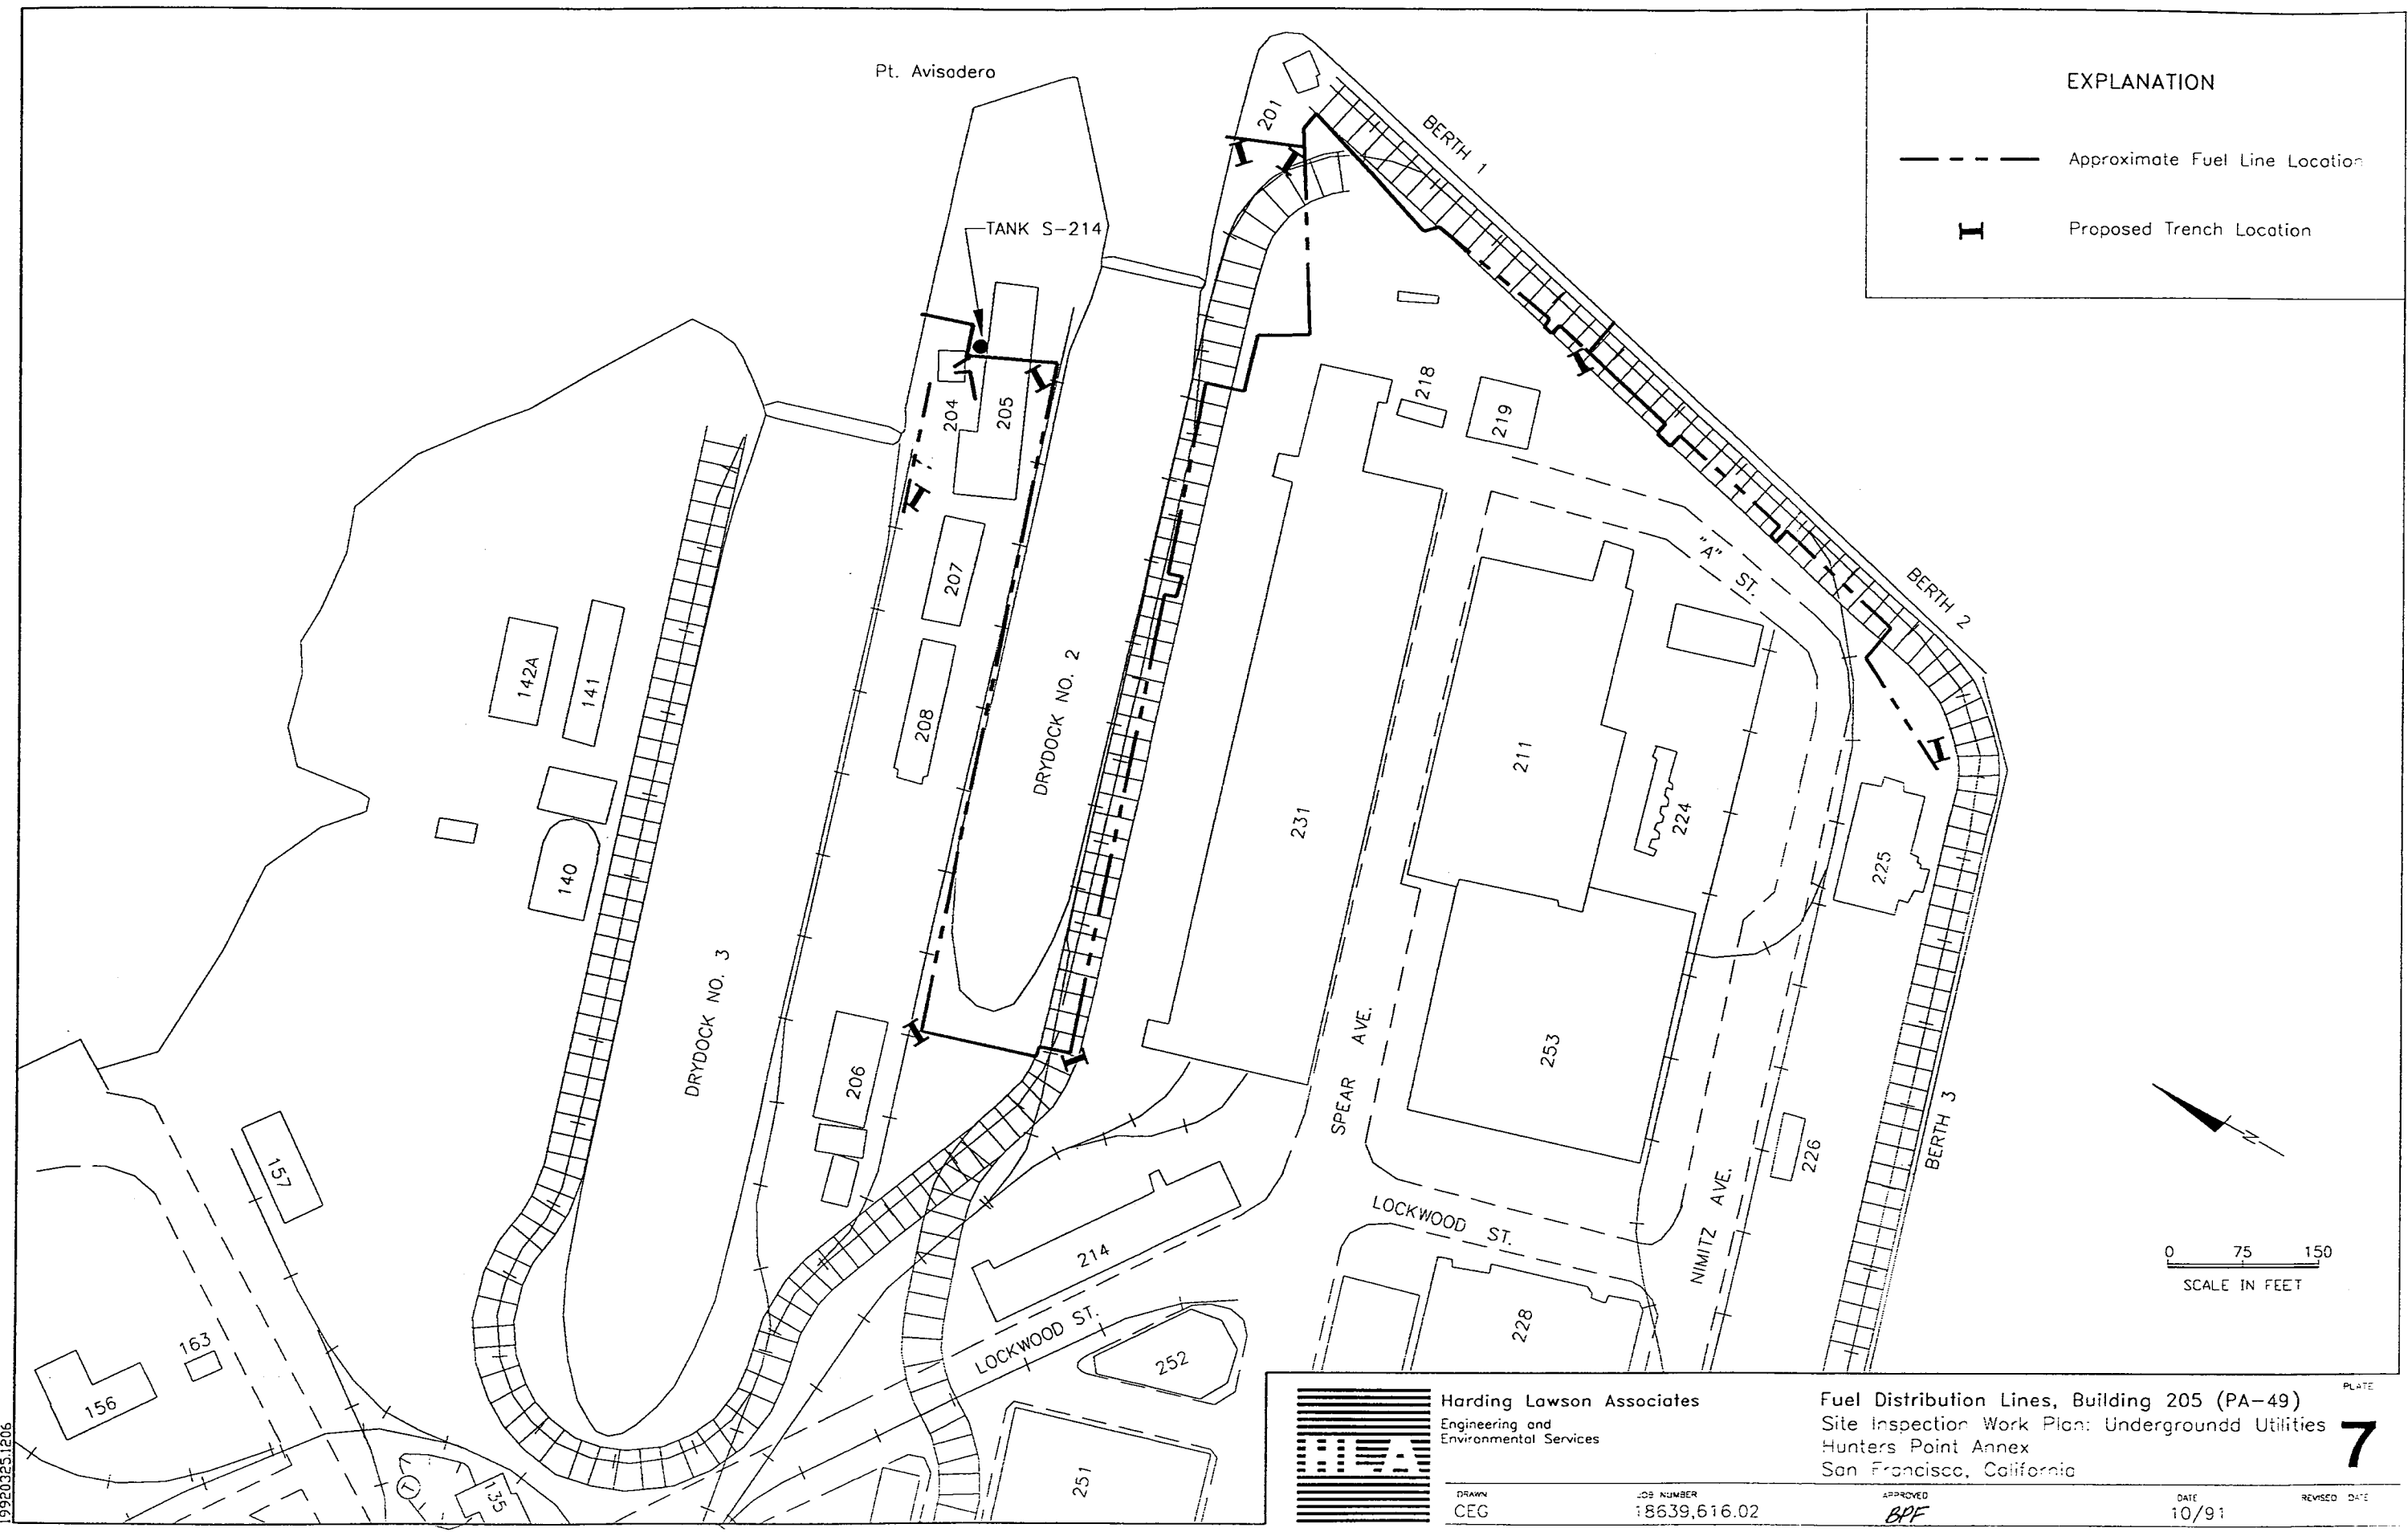
Harding Lawson Associates		Fuel Distribution Lines, Building 205 (PA-49)		7
	Engineering and Environmental Services		Site Inspection Work Plan: Underground Utilities		
			Hunters Point Annex		
		San Francisco, California			
DRAWN CEG		JOB NUMBER 18639,616.02		APPROVED BPF	
				DATE 10/91

EXPLANATION

--- Approximate Fuel Line Location
